# Smoke and Dye Testing Summary

## High Level Sewershed

| Test ID | Test Type | Date Inspected | Company / Super. | Blower MH | Ground Condition | Notification Made? | Total Length |
|---|---|---|---|---|---|---|---|
| S1028-016 | Smoke | 8/8/2008 | ADS/TM | S07UU_001MH | Dry | Yes | 1,375.66 |

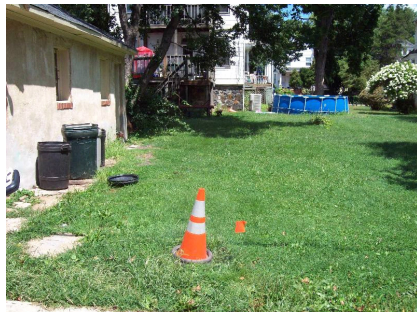
**Picture** \S1028-016-OB01-P01.jpg

**Comments** Smoke from cleanout in back yard. 3625 Springdale Ave.

**Comments** Back of house, 3625 Springdale Ave.

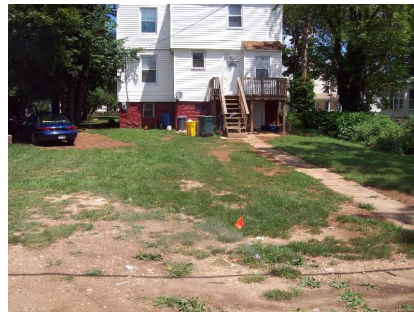
**Picture** \S1028-016-OB02-P01.jpg

**Comments** Smoke from cleanout in back yard. 3623 Springdale Ave.

**Comments** Back of house, 3623 Springdale Ave.

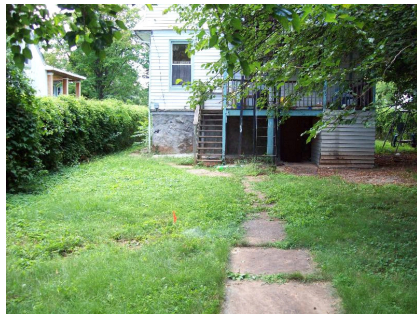
**Picture** \S1028-016-OB05-P01.jpg

**Comments** Smoke from cleanout in back yard. 3616 Fairview Ave.

**Comments** Back of house, 3616 Fairview Ave.

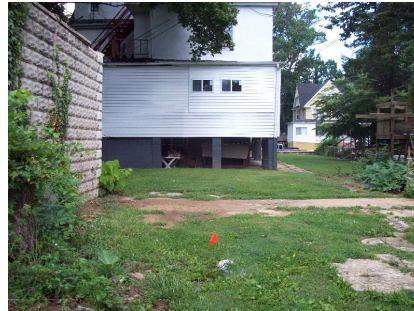
**Picture** \S1028-016-OB04-P01.jpg

**Comments** Smoke from cleanout in back yard. 3620 Fairview Ave.

**Comments** Back of house, 3620 Fairview Ave.
